# Experimental Investigation of the Elastic Moduli of Existing Minangkabau Wooden Buildings using Non-Destructive Testing

**Introduction:** The existing Minangkabau traditional wooden buildings that are more than 100 years old are commonly found in Tanah Datar Regency, West Sumatra Province, Indonesia. However, it is necessary to assess the residual strength of the wood to evaluate the main structural members, such as beams and main columns, which may have experienced a decrease in strength. The aim of this research is to carry out non-destructive testing to obtain the dynamic elastic moduli of the existing buildings.

**Methods:** Non-destructive testing was conducted using ultrasound technology specifically designed for wood. The members studied were the main columns and beams of the existing buildings. This study focused on the two existing Minangkabau wooden buildings located in Tanah Datar Regency.

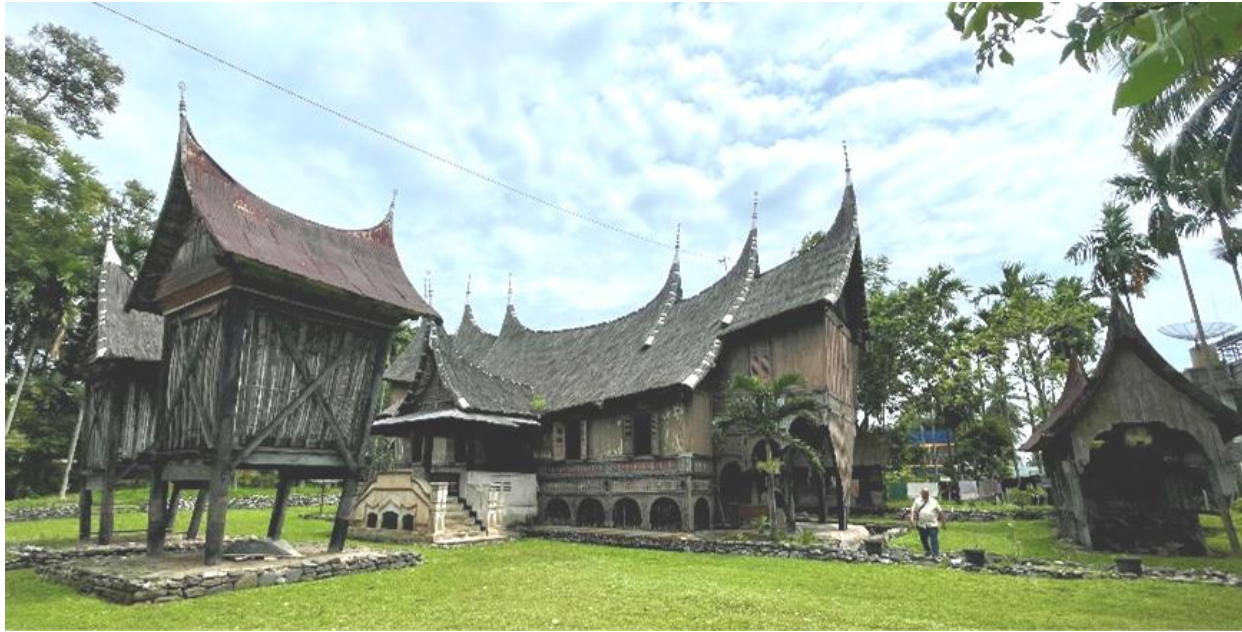
**Fig. (1).** The first existing building, namely Rumah Gadang Datuak Bandaro Kuniang.

existing buildings were studied, both classified as historic structures. The first building, Rumah Gadang Datuak Bandaro Kuniang (coordinates: -0.4617653266, 100.5713323962), is shown in Fig. (1). The second building, Rumah Tuo Kampai nan Panjang Balimbiang (coordinates: -0.5224518903, 100.5699440901), is shown in Fig. (2). Non-destructive testing was conducted using ultrasound technology for wood quality assessment by employing the Sylvestest 4 [8] test equipment. The buildings members studied were the main columns and beams. To obtain consistent velocity data, the column and beam elements selected for testing had a dry moisture content ranging from 10% to 18% [2]. The temperature conditions in the area where the buildings are located are above 0°C, so the velocity test data do not require correction with an adjustment factor [2].

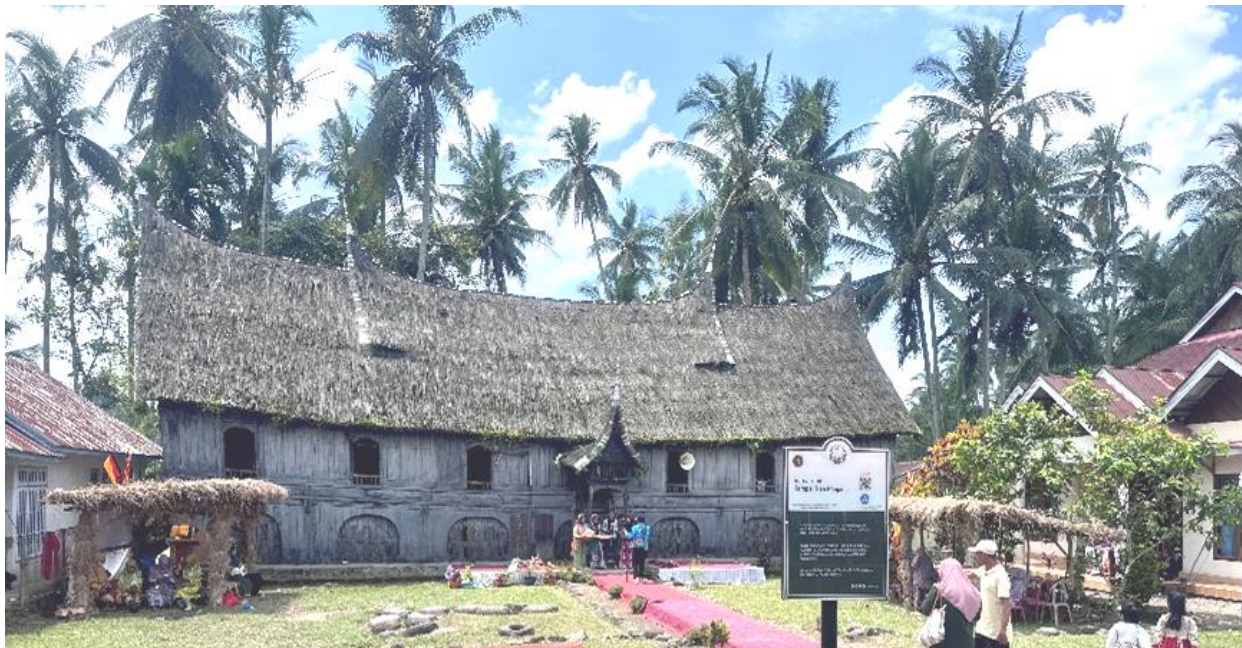
**Fig. (2).** The second existing building, namely Rumah Tuo Kampai Nan Panjang, Balimbiang.

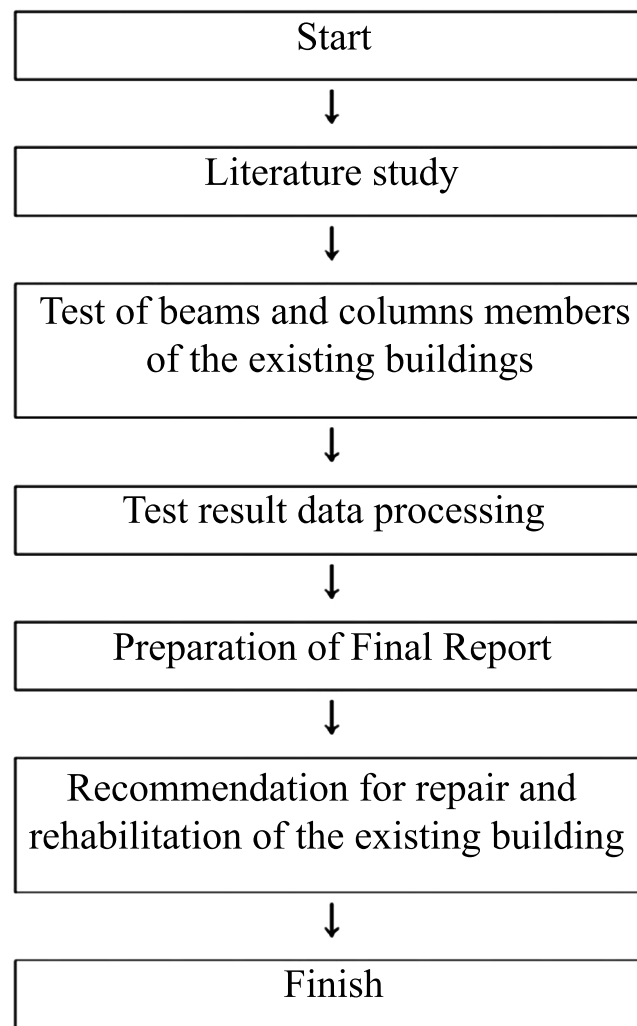
Fig. (3). Flowchart and method of research.

The results of the study provide information on whether the elastic moduli of the existing buildings remain within the range of undamaged wood or if they have experienced a decrease in strength. This information is very important to provide recommendations on whether to replace wooden components in existing buildings if there has been a decrease in strength or damage. The flowchart of the research is shown in Fig. (3).

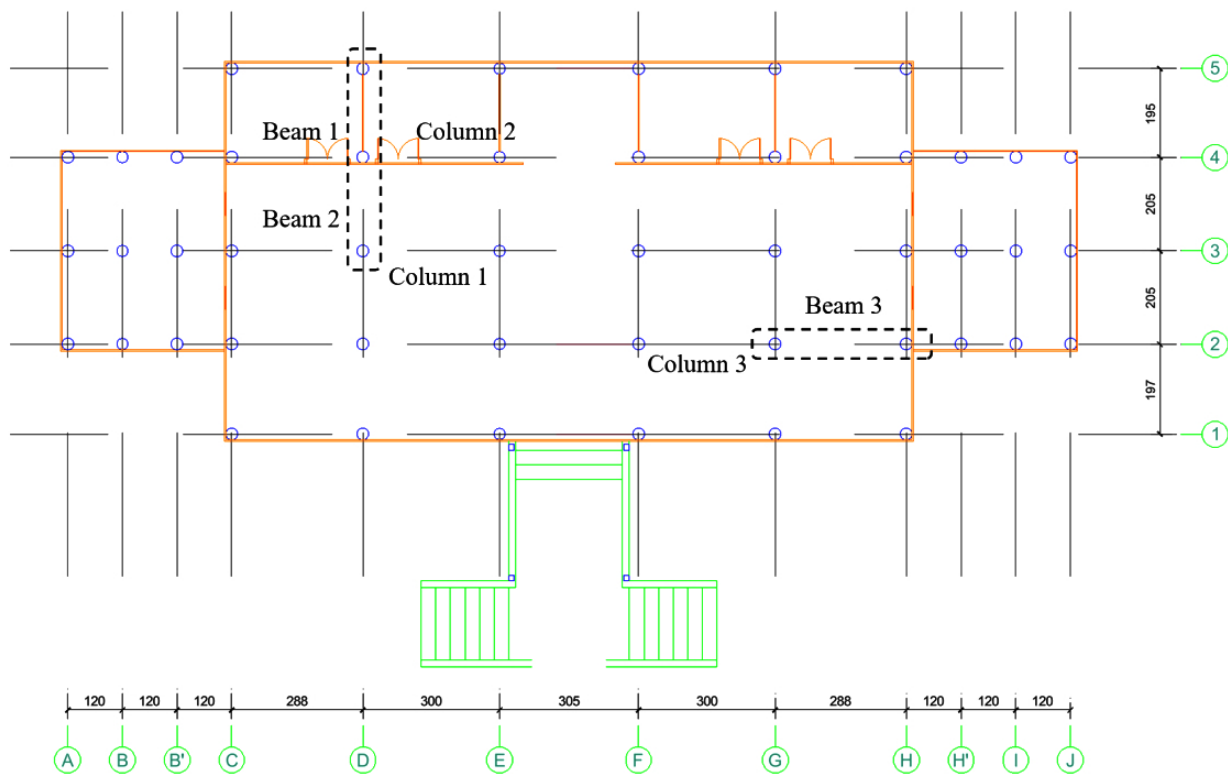
**Fig. (5).** The floor plan of the first building. The main columns and main beams were tested.

Two wooden buildings were studied. The first building had a floor plan, as shown in Fig. (5). Fig. (6) shows the

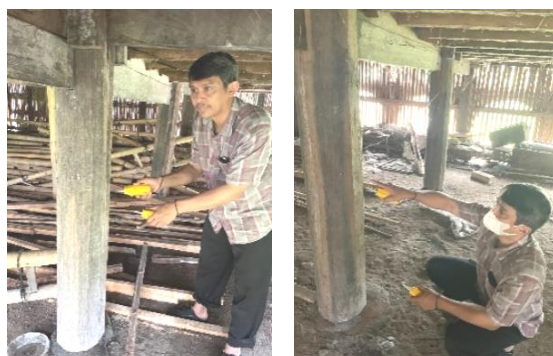
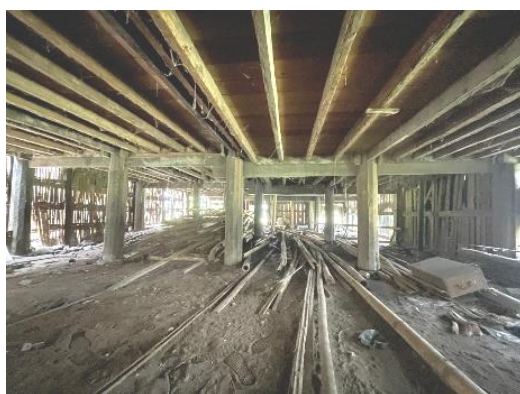
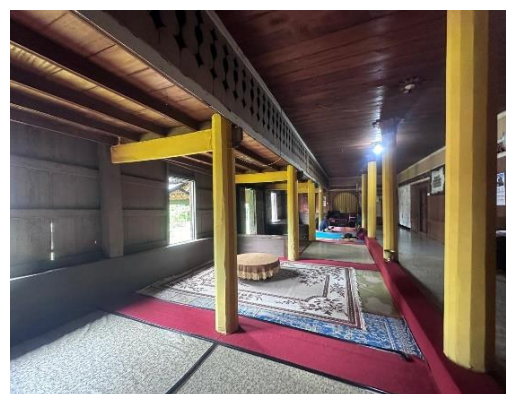
(a). The main columns of the first building

(b). Ground level of the first building

(c). +2,2 Meter level of the first building

**Fig. (6a-c).** The first existing building, rumah gadang datuak bandaro kuniang.

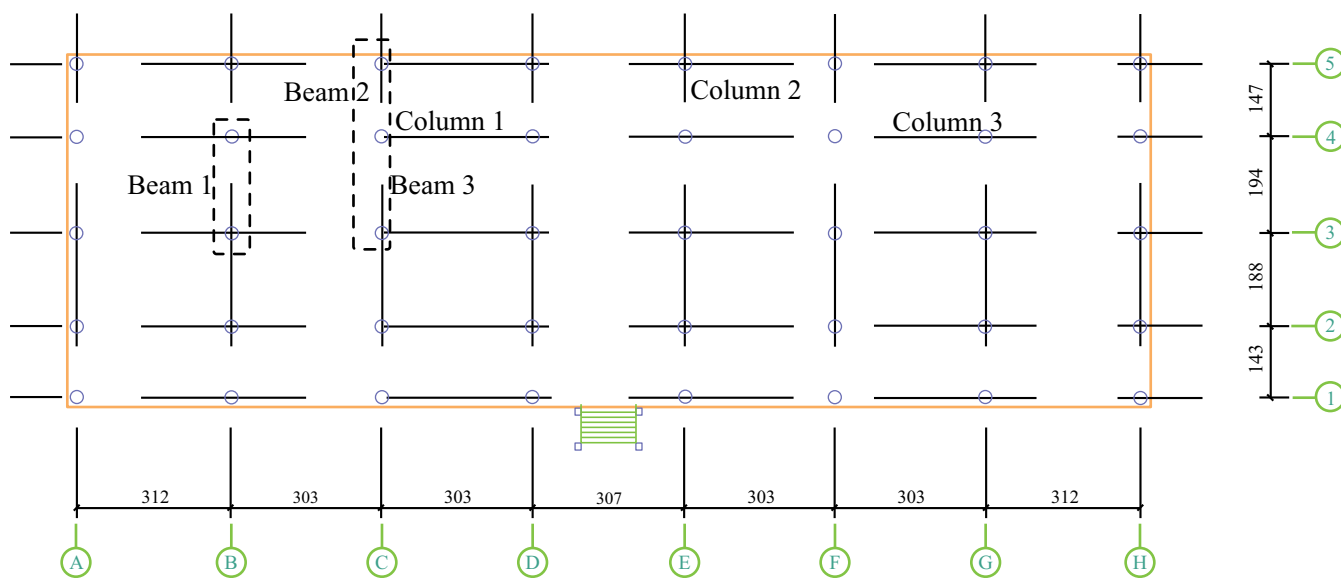
**Fig. (7).** The floor plan of the second building. The main columns and main beams were tested.

testing process for the first building. The floor plan of the second building is shown in Figs. (7, and 8) depicts the testing process for the second building.

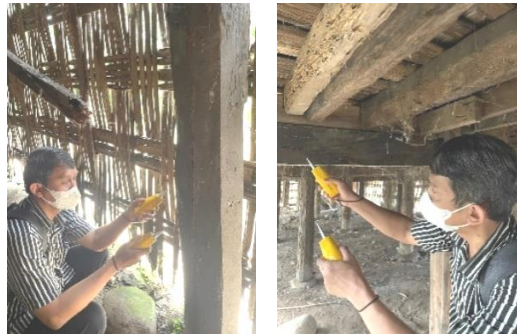
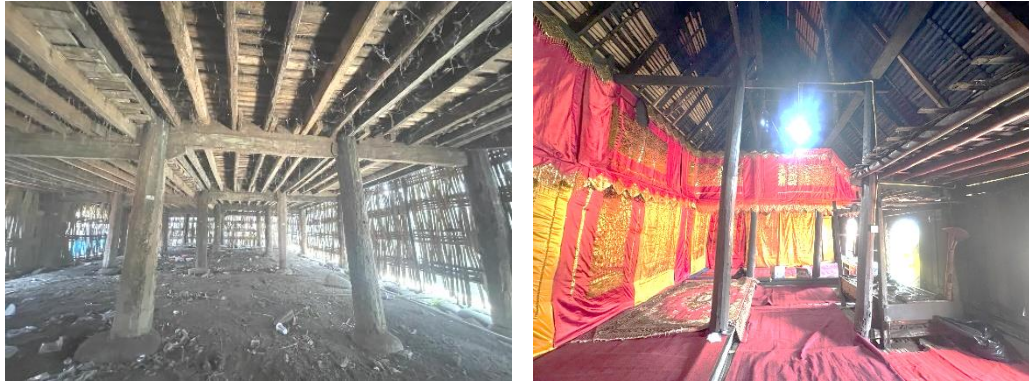
(a). The main column and beam of the second building

(b). Ground level of the second building (c). +2,2 Meter level of the second building

**Fig. (8a-c).** The second existing building, rumah tuo kampai nan panjang balimbiang .

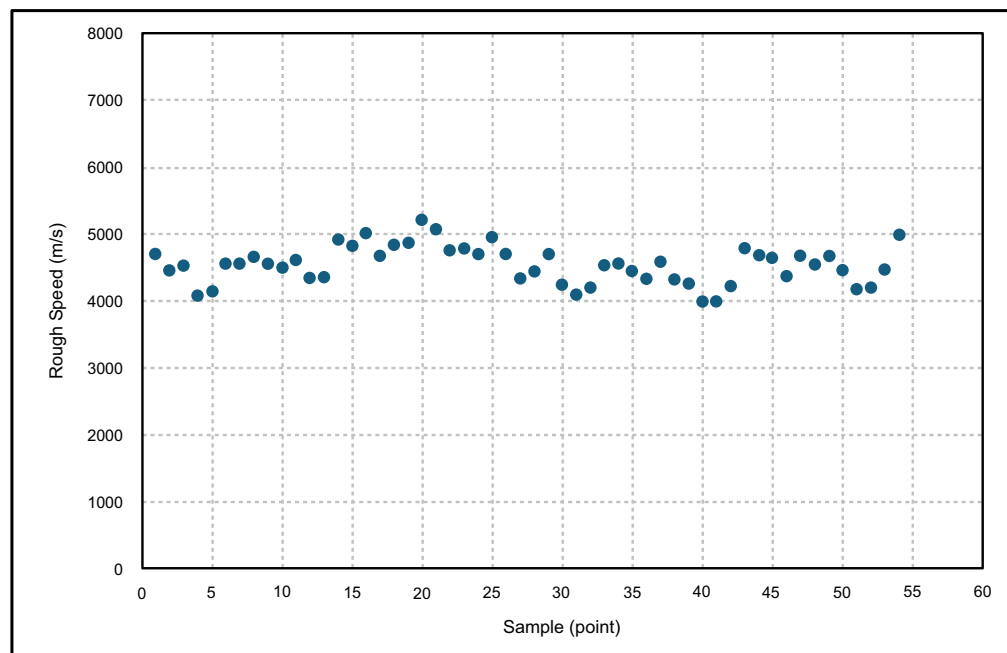
**Fig. (9).** Results of the velocities (rough speeds) obtained from non-destructive testing of the first existing building.

Both the transducer and receiver were not blocked by the surface layer of wood. The complete test results for the two buildings are shown in Fig. (9) (first existing building) and Fig. (10) (second existing building), representing the direct velocities ( $V$ ) of the timber logs.

The test results generally indicated that the velocity ( $V$ ) obtained ranged from 4000 m/s to 5226 m/s with a mean value of 4558.54 m/s, a standard deviation of 281.95 m/s, and a coefficient of variation of 6.19% for the first building, while for the second building, a velocity ranging from 3497 m/s to 4747 m/s was obtained with a mean of 3972.26 m/s, a standard deviation of 303.6 m/s, and a coefficient of variation of 7.64%. These results were then further processed into dynamic elastic modulus parameters using Equation 1. The complete calculation results are shown in Fig. (11) for the first building and Fig. (12) for the second building.

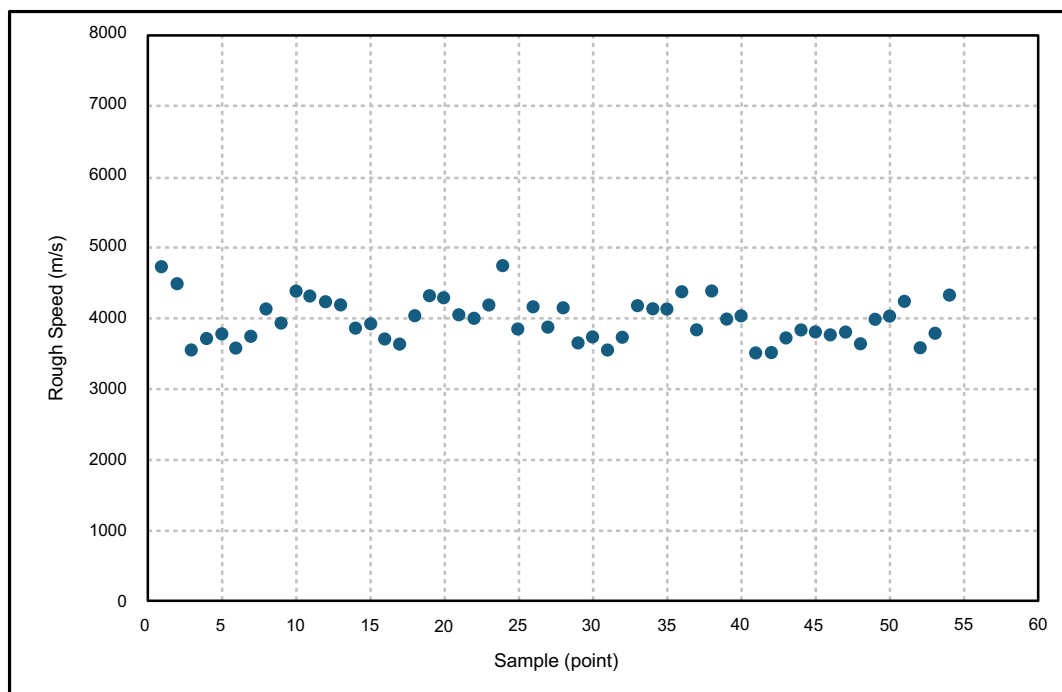
**Fig. (10).** Results of the velocities (rough speeds) obtained from non-destructive testing of the second existing building.

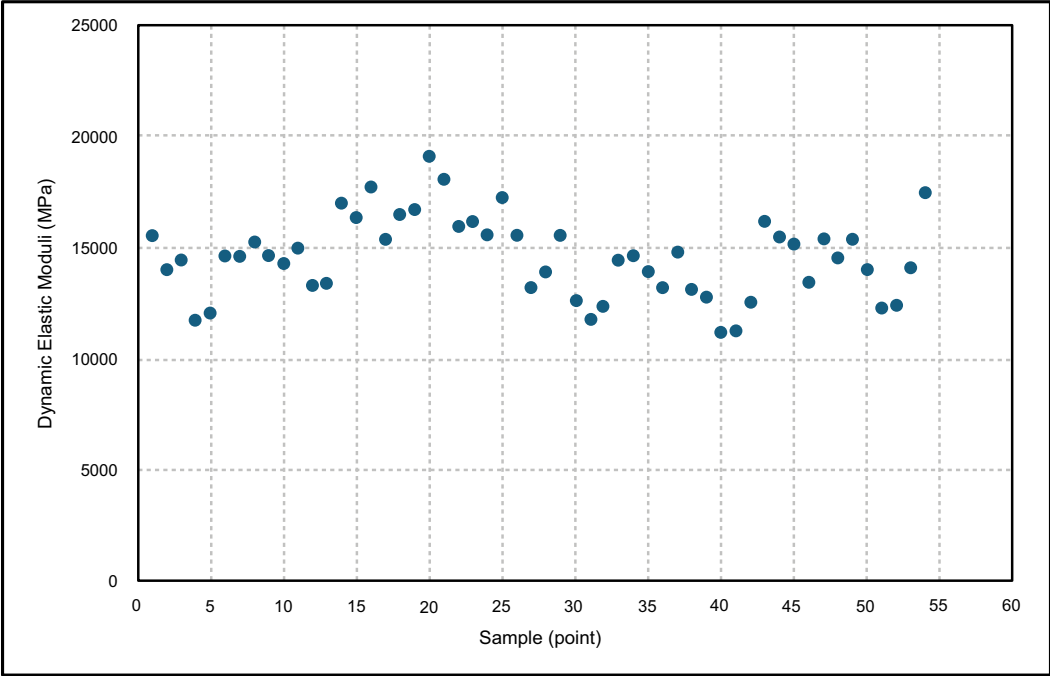
**Fig. (11).** Results of the dynamic elastic modulus of the first existing building.

These dynamic elastic moduli ( $MoE_d$ ) values were then converted into elastic moduli ( $MoE$ ) using Equation 2 [7]. The dynamic elastic modulus has a ratio of 1.42 to the static elastic modulus when the velocity is measured using ultrasound. The complete calculation results are presented in Table 2, indicating that the elastic modulus of the first existing building (Rumah Gadang Datuak Bandaro Kuniang) has a trend similar to the one observed in several studies [15-18]. These results matched with visual observation that the tested columns and beams did not experience damage.

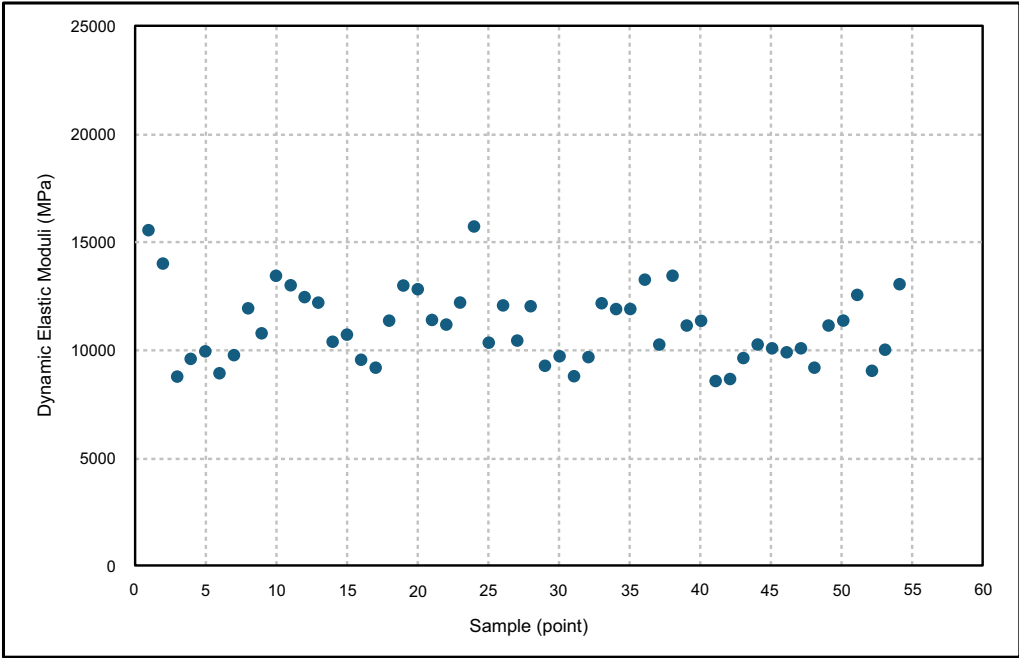
**Fig. (12).** Results of the dynamic elastic modulus for the second existing building.

However, the test results for the second building (Rumah Tuo Kampai nan Panjang) demonstrated a lower elastic modulus, indicating that the beams and columns selected for testing had experienced a decrease in strength with a relative difference of 28.23% to 35.18%

lower than the reference [17, 16]. Based on visual observations during testing of the second building, there was indeed a decrease in strength because the main beams began to be damaged due to the influence of the weather.
