# Experimental Investigation of the Elastic Moduli of Existing Minangkabau Wooden Buildings using Non-Destructive Testing

### Experimental Investigation of the Elastic Moduli of Existing Minangkabau Wooden Buildings using Non-Destructive Testing

Methods: Non-destructive testing was conducted using ultrasound technology specifically designed for wood. The members studied were the main columns and beams of the existing buildings. This study focused on the two existing Minangkabau wooden buildings located in Tanah Datar Regency.

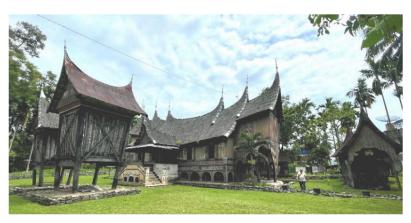
$\textbf{Fig. (1).} \ \ \textbf{The first existing building, namely Rumah Gadang Datuak Bandaro Kuniang}.$

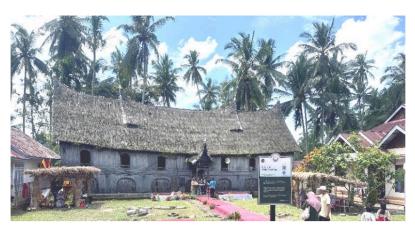
$\textbf{Fig. (2).} \ \ \textbf{The second existing building, namely Rumah Tuo Kampai Nan Panjang, Balimbiang}.$

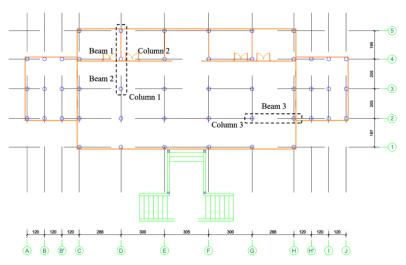
Fig. (5). The floor plan of the first building. The main columns and main beams were tested.

Two wooden buildings were studied. The first building had a floor plan, as shown in Fig. (5). Fig. (6) shows the

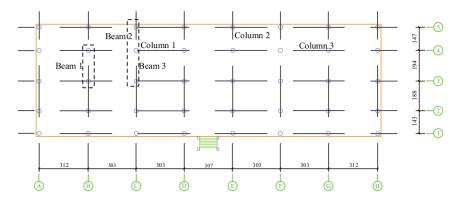
$\textbf{Fig. (7).} \ \ \textbf{The floor plan of the second building.} \ \ \textbf{The main columns and main beams were tested.}$

testing process for the first building. The floor plan of the second building is shown in Figs. (7, and 8) depicts the testing process for the second building.
