Shoreline Detection using Image Processing for Coast of Pangandaran

O. Pattipawaej^{1,2,*}

ABSTRACT

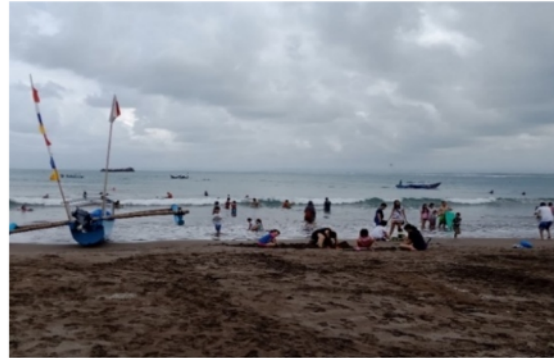
Figure 2: Condition of the Pangandaran West Coast at Coordinates 07° 41' 52,64" S; 108° 39' 09,20" E.

The first stage was carried out field observations on Pangandaran coastal area. The thing to do is to inspect the location, observe the coastal area, such as: abrasion, land use around the coastal Pangandaran, and community activities around Pangandaran coastal area. The condition of Pangandaran coastal can be seen in Figure 2 to Figure 4.

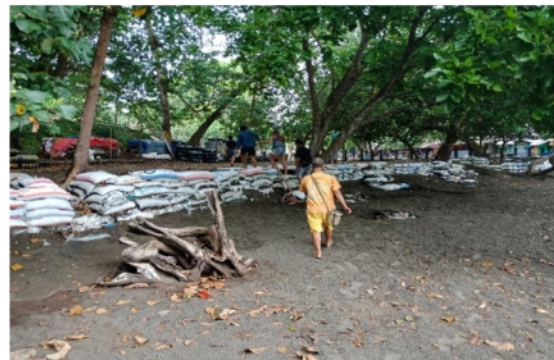
Figure 3: Coastal Condition of Batu Hiu coastal in Pangandaran at Coordinates 07° 41' 33,72" S; 108° 32' 18,76" E.

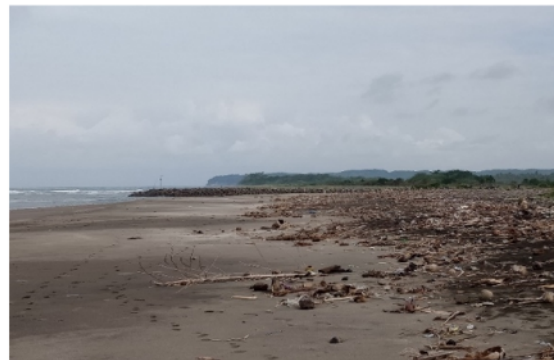
Figure 4: Condition of the Batu Hiu coastal area in Pangandaran at Coordinates 07° 42' 09,71" LS; 108° 30' 41,52" BT.

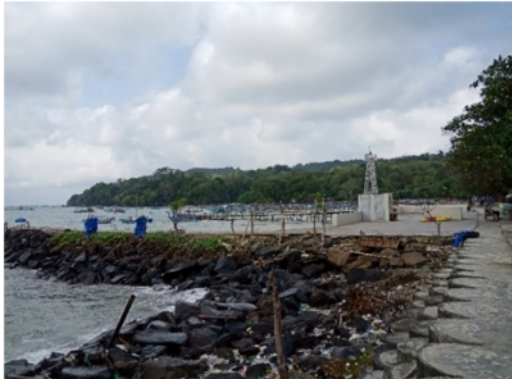
Figure 5: Condition of Breakwater in East Coast Pangandaran at Coordinates $07^{\circ} 41' 55,62''$ S; $108^{\circ} 39' 33,20''$ E.

The condition of breakwater at Pangandaran Beach can be seen in Figure 5 to Figure 7.

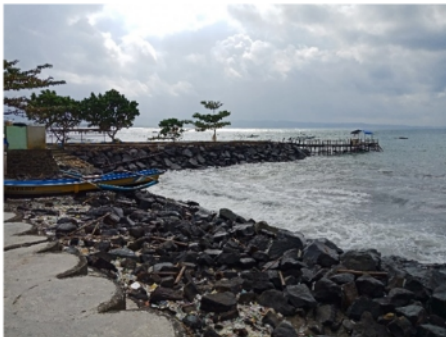
Figure 6: Condition of Breakwater in the East Coast Pangandaran at Coordinates $07^{\circ} 41' 54,69''$ S; $108^{\circ} 39' 33,54''$ E.

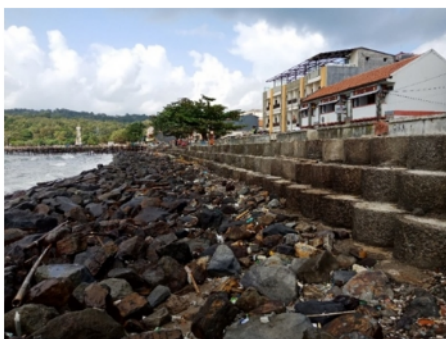
Figure 7: Conditions of Breakwater in the East Coast Pangandaran at Coordinates $07^{\circ} 41' 55,93''$ S; $108^{\circ} 39' 33,23''$ E.

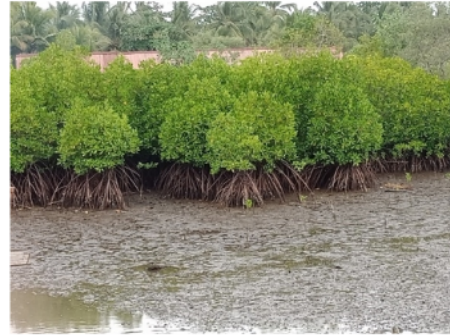
Figure 8: Plant Condition Part 1 on the Batu Hiu at Coordinates $07^{\circ} 41' 33,72''$ S; $108^{\circ} 32' 18,76''$ E.

Planting plants around Pangandaran coastal area which is used as a barrier to erosion and/or sedimentation can be seen in Figure 8 to Figure 9.

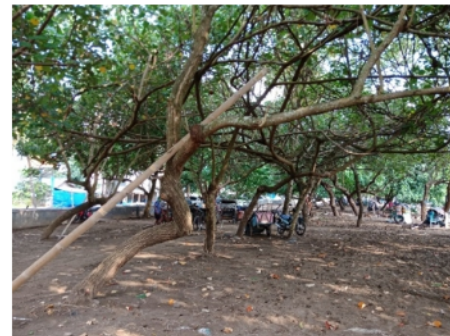
Figure 9: Condition of Plants Section 2 on the West Coast of Pangandaran at Coordinates $07^{\circ} 42' 03,47''$ S; $108^{\circ} 39' 23,20''$ E.

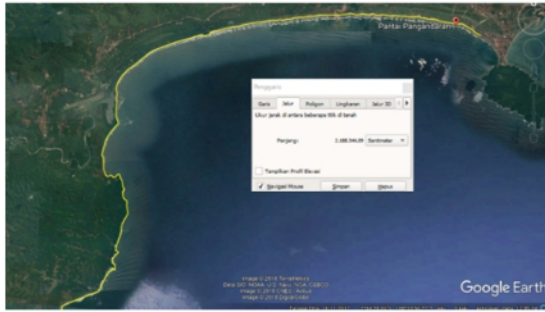
Figure 10: Distance on Google Earth.

Changes to the coastline can be seen through the Google Earth Pro application, by plotting an image of the Pangandaran Beach location in the AutoCAD application. The distance to the image obtained from Google Earth Pro is obtained by using the ruler of the application which can be seen in Figure 10.

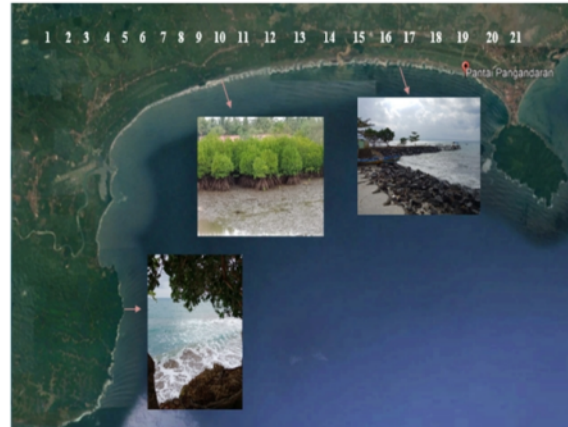
Figure 13: Condition at some point of Pangandaran Beach.

The largest average shoreline change due to erosion is 0.32 m at point 3a and due to sedimentation is 0.07m at point 3c, respectively. The shoreline changes at Pangandaran Beach at points 1-7 experienced a large shoreline change because around the coast there were no breakwater buildings or mangrove plants. While points 8-13 shoreline changes were not too large due to mangrove planting around the coast. At points 14-21 experienced a change in the coastline not too large also because there were breakwater buildings around the coast. Figure 13 shows the condition at some points of Pangandaran seashore.
