International Conference on Environmentally Friendly Civil Engineering Construction and Materials *"Creating and Adapting Sustainable Technologies"*

13-14 November 2014 Manado - Indonesia

EVALUATION OF COASTAL VULNERABILITY ASSESSMENT AND COASTAL MANAGEMENT FOR KARANGANTU COASTAL AREA IN BANTEN - INDONESIA

Coastal and offshore protection and engineering

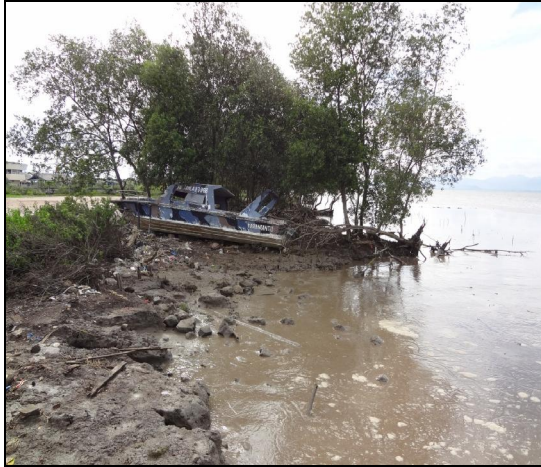
The Jetty at Karangantu's coastal area has already damaged caused by the wave, so it is necessary to repair the Jetty. In addition, the condition of the shoreline on the left of Jetty's structure encountered the erosion problems. This erosion occurred because the sediment transport processes that hampered the existing Jetty. Eroded shoreline conditions of Karangantu's coastal area can be seen in Figure 10. In addition there is also the problem of silting the estuary, making it difficult for boats with larger sizes to enter and exit. Estuary silting problems can be seen in Figure 11 and the damage of Karangantu's jetty can be seen in Figure 12.

Figure 10: Conditions Shorelines eroded at Karangantu's coastal area

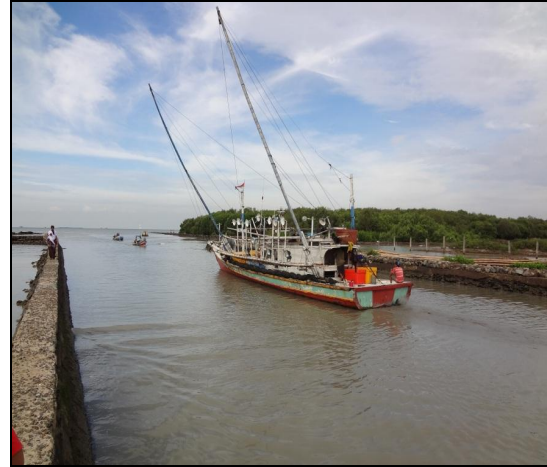
Figure 11: Estuary Siltation at Karangantu's coastal area

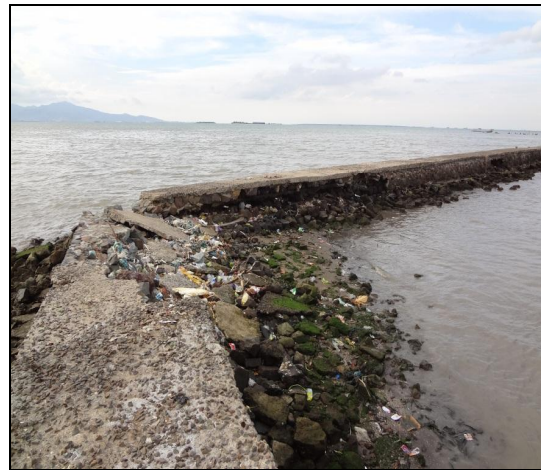
Figure 12: Damage condition on Karangantu's Jetty

Based on the Karangantu's Coastal Vulnerability Index value of 84.3 and based on the level of vulnerability (Table 2) can be determined that the vulnerability of coastal Karangantu classified as very high. In the other hand, with a very high degree of vulnerability, the priority coastal management for Karangantu's coastal area is extremely preferred to make the soft and/or hard coastal protection structure. The existing Jetty at Karangantu's coastal area is also extremely preferred to repair soon.
